**Flood Control Project Maintenance
Levee Inspections**

Maintenance Issue Types Only, Levee Inspection Report By Mile - Spring 2019

Reclamation District No. 2060 Hastings

Waterway	Bank	Unit Miles	Inspection Start/End	Inspector
Unit No. 01 Lindsey Slough	Left	6.97	04/09/2019 04/09/2019	David Julian

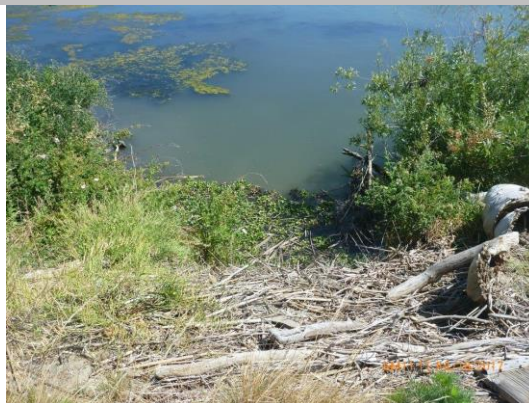
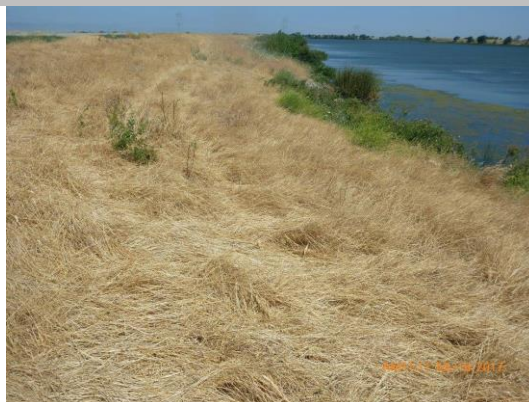
LM Start	2.55	Rating **	M	Issue No.	33 (cont)
LM End	2.55	Issue Type +	Ma	Location *	
Category	Supplemental			GPS Latitude/Longitude	
				Start	End
Item	2017 Storm Damage			38.277956 °	38.277928 °
				-121.712814 °	-121.712775 °
DWR ID	DWR_RD2060_03_f _ 2017_33				
Comment Code					
Inspector Comment					
Levee Evaluation Comments					
Description:Erosion commences approximately halfway down the slope and extends to the waterside toe.					
Site ID No:402					
Site Designation:LMA-229					
Repair Type: Erosion					
Rating:Area of Concern					
Field Date:7/18/2017					
Notes: Small but deep vertical cut down to water.

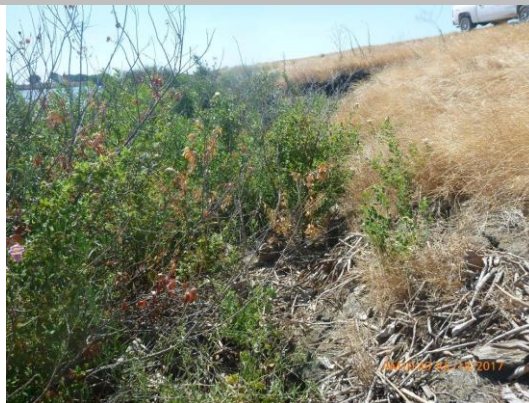
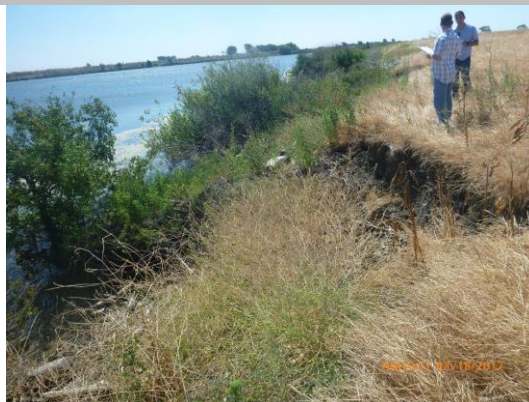
LM Start	2.56	Rating **	A/W	Issue No.	34
LM End	2.58	Issue Type +	Ma	Location *	
Category	Supplemental			GPS Latitude/Longitude	
				Start	End
Item	2017 Storm Damage			38.277850 °	38.277706 °
				-121.712639 °	-121.712414 °
DWR ID	DWR_RD2060_03_f_2017_34				
Comment Code					
Inspector Comment					
Levee Evaluation Comments					
Description:Erosion commences approximately 1/4 of the way down the slope and results in sloughing into the waterside toe.					
Site ID No:403					
Site Designation:LMA-230					
Repair Type: Erosion					
Rating:Serious					
Field Date:7/18/2017					
Notes: Erosion causing sloughing. Horizontal cracks about 6' up from erosion.

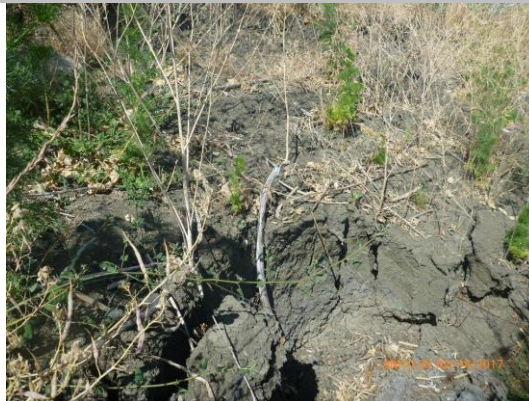
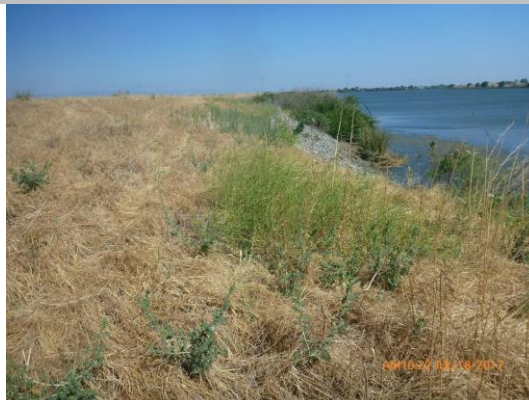
LM Start	2.64	Rating **	M	Issue No.	35 (cont)	
LM End	2.64	Issue Type +	Ma	Location *		
Category	Supplemental			GPS Latitude/Longitude		
				Start	End	
Item	2017 Storm Damage			38.277106°	38.277078°	
				-121.711489°	-121.711447°	
DWR ID	DWR_RD2060_03_f _ 2017_35					
Comment Code						
Inspector Comment						
Levee Evaluation Comments						
Description:Erosion commences approximately 1/4 of the way down the slope and results in sloughing into the waterside toe.						
Site ID No:404						
Site Designation:LMA-231						
Repair Type: Erosion						
Rating:Area of Concern						
Field Date:7/18/2017						
Notes: Small erosion and sloughing adjacent to revetted slope.

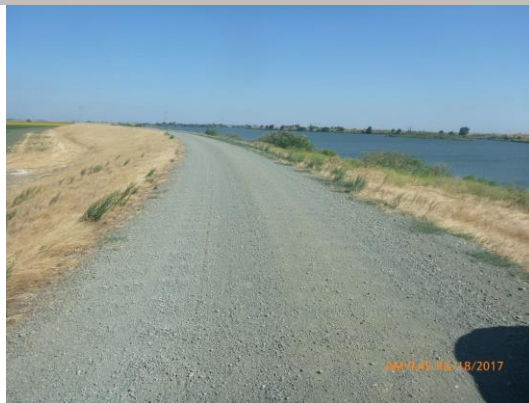
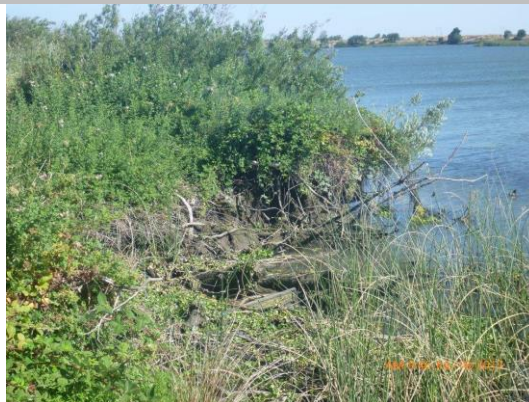
LM Start	2.69	Rating **	A/W	Issue No.	36
LM End	2.73	Issue Type +	Ma	Location *	
Category	Supplemental			GPS Latitude/Longitude	
				Start	End
Item	2017 Storm Damage			38.276608 °	38.276133 °
				-121.710811 °	-121.710394 °
DWR ID	DWR_RD2060_03_f _ 2017_36				
Comment Code					
Inspector Comment					
Levee Evaluation Comments					
Description:Sloughing commences approximately halfway down the slope and extends to the waterside toe.					
Site ID No:405					
Site Designation:LMA-232					
Repair Type: Erosion					
Rating:Serious					
Field Date:7/18/2017					
Notes: Vertical cut at highwater mark.

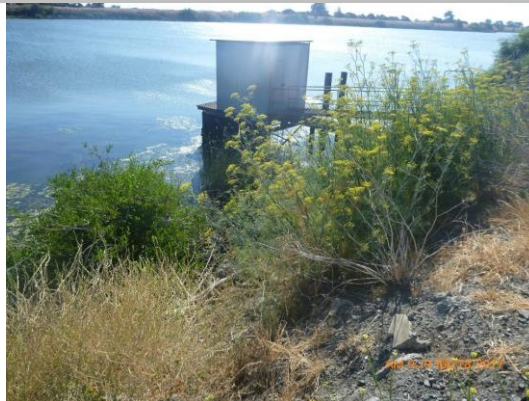
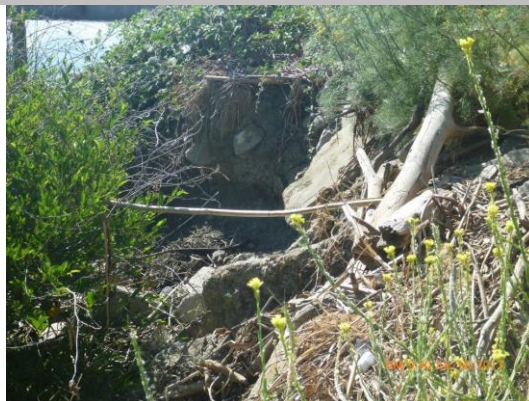
LM Start	3.24	Rating **	M	Issue No.	37 (cont)	
LM End	3.24	Issue Type +	Ma	Location *		
Category	Supplemental			GPS Latitude/Longitude		
				Start	End	
Item	2017 Storm Damage			38.270231 °	38.270203 °	
				-121.705897 °	-121.705856 °	
DWR ID	DWR_RD2060_03_f_2017_37					
Comment Code						
Inspector Comment						
Levee Evaluation Comments						
Description:Erosion commences approximately halfway down the slope and results in sloughing into the waterside toe. Existing rip rap has been pulled off the slope at this site.						
Site ID No:406						
Site Designation:LMA-233						
Repair Type: Erosion						
Rating:Area of Concern						
Field Date:7/18/2017						
Notes: Erosion is next to a pumphouse and slope is protected withrip rap.

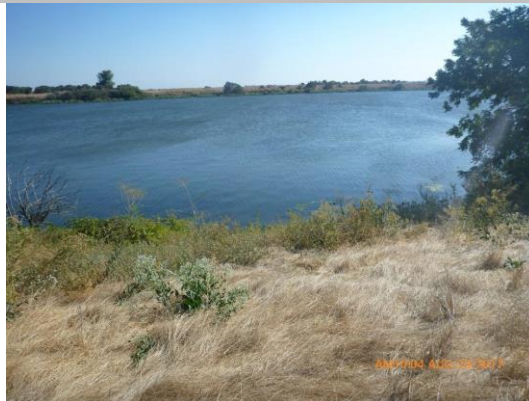
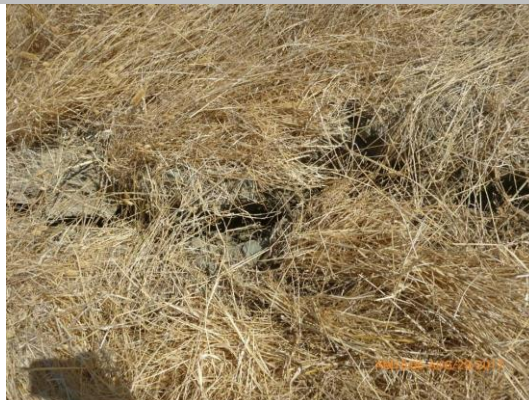
LM Start	3.59	Rating **	M	Issue No.	38
LM End	3.63	Issue Type +	Ma	Location *	
Category	Supplemental			GPS Latitude/Longitude	
				Start	End
Item	2017 Storm Damage			38.266408 °	38.266047 °
				-121.701650 °	-121.701061 °
DWR ID	DWR_RD2060_03_f_2017_38				
Comment Code					
Inspector Comment					
Levee Evaluation Comments					
Description:MBK Delta Erosion Sites_6-29-2017					
Site ID No:484					
Site Designation:LMA-322					
Repair Type: Erosion					
Rating:Area of Concern					
Field Date:8/29/2017					
Notes:

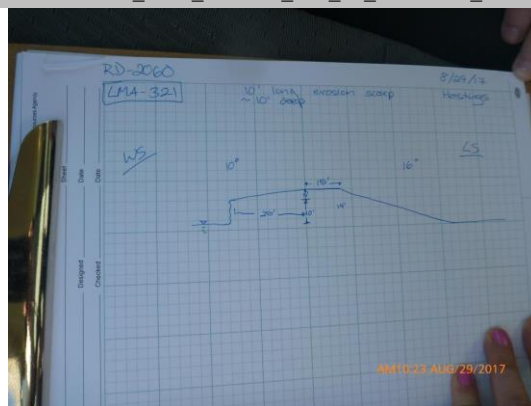
Photo 1 of 1 : SP_2019_RD2060_243_39_20190311_00066.jpg

LM Start	3.66	Rating **	M	Issue No.	39	
LM End	3.71	Issue Type +	Ma	Location *		
Category	Supplemental			GPS Latitude/Longitude		
				Start	End	
Item	2017 Storm Damage			38.265742 °	38.265342 °	
				-121.700522 °	-121.699881 °	
DWR ID	DWR_RD2060_03_f_2017_39					
Comment Code						
Inspector Comment						
Levee Evaluation Comments						
Description:MBK Delta Erosion Sites_6-29-2017						
Site ID No:483						
Site Designation:LMA-321						
Repair Type: Erosion						
Rating:Area of Concern						
Field Date:8/29/2017						
Notes:

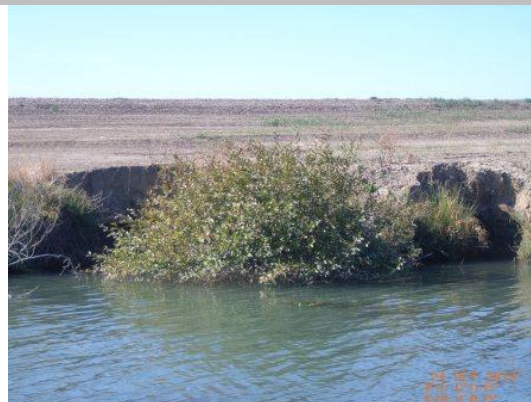
Photo 1 of 1 : SP_2019_RD2060_243_4_20190311_00001.jpg

LM Start	3.78	Rating **	A/W	Issue No.	4
LM End	4.09	Issue Type +	Ma	Location *	WS
Category	Supplemental			GPS Latitude/Longitude	
				Start	End
Item	2017 USACE Erosion Survey, DRAFT			38.264585 °	38.260593 °
				-121.698868 °	-121.696403 °
DWR ID	DWR_RD2060_03_f_2018_4				
Comment Code					
Inspector Comment					
2017 Site ID: CHS 21.1 R					
Status: Eroding					
2017 Field Notes: Significant toe erosion within last year.					
Site History: 2011 - Several pockets of erosion from rotational failure and slumping toe. 2013 - Site extended downstream to include new erosion pockets. 2016 - New rock in one of the erosion spots.

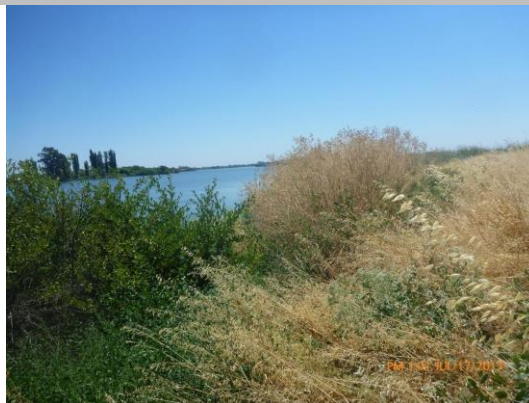
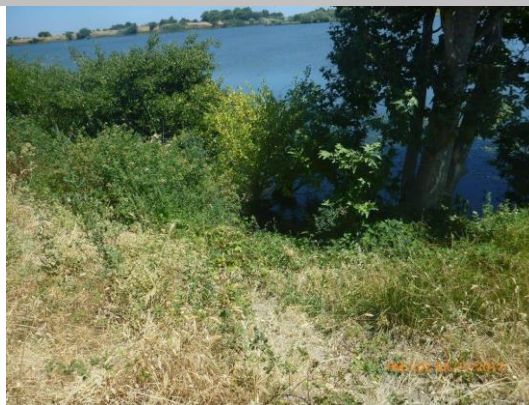
LM Start	3.82	Rating **	A/W	Issue No.	40
LM End	3.94	Issue Type +	Ma	Location *	
Category	Supplemental			GPS Latitude/Longitude	
				Start	End
Item	2017 Storm Damage			38.264006 °	38.262364 °
				-121.698811 °	-121.698103 °
DWR ID	DWR_RD2060_03_f _ 2017_40				
Comment Code					
Inspector Comment					
Levee Evaluation Comments					
Description:Erosion commences approximately halfway down the slope and results in sloughing into the waterside toe. Existing rip rap has been pulled off the slope at this site					
Site ID No:410					
Site Designation:LMA-237					
Repair Type: Erosion					
Rating:Serious					
Field Date:7/18/2017					
Notes: This site is combined with LMA-234. There is minor toe erosion along whole 631 lf, but there is a 20' wide deep erosion at 38.26347, -121.69859. That is the only location that is serious and is likely due to a collapsed beaver den.

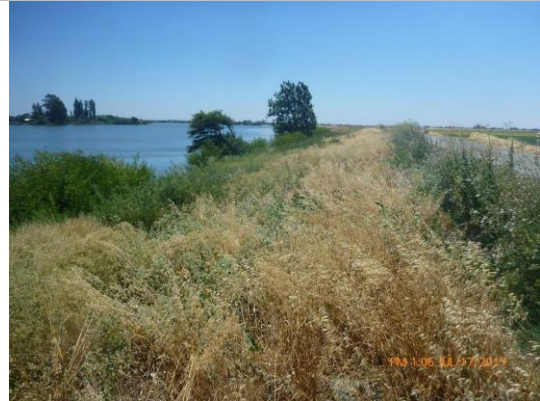
Photo 3 of 3 : SP_2019_RD2060_243_40_20190311_00069.jpg

Comment Code						
Inspector Comment						
Levee Evaluation Comments						
Description:Erosion commences approximately halfway down the slope and results in sloughing into the waterside toe. Existing rip rap has been pulled off the slope at this site						
Site ID No:410						
Site Designation:LMA-237						
Repair Type: Erosion						
Rating:Serious						
Field Date:7/18/2017						
Notes: This site is combined with LMA-234. There is minor toe erosion along whole 631 lf, but there is a 20' wide deep erosion at 38.26347, -121.69859. That is the only location that is serious and is likely due to a collapsed beaver den.

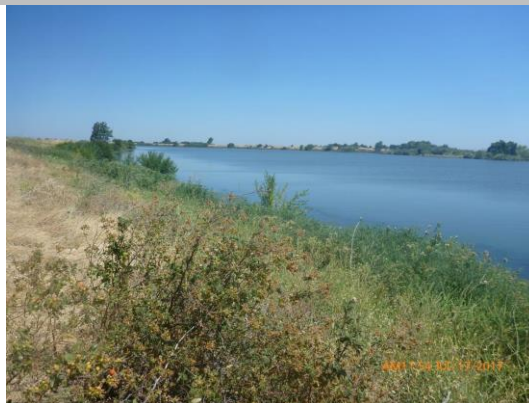
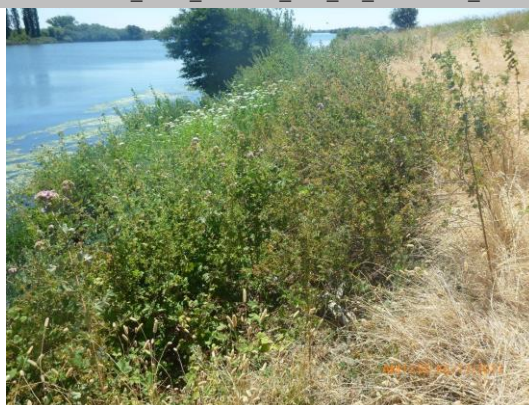
LM Start	4.06	Rating **	A/W	Issue No.	42
LM End	4.08	Issue Type +	Ma	Location *	
Category	Supplemental			GPS Latitude/Longitude	
				Start	End
Item	2017 Storm Damage			38.260789 °	38.260644 °
				-121.696964 °	-121.696828 °
DWR ID	DWR_RD2060_03_f _ 2017_42				
Comment Code					
Inspector Comment					
Levee Evaluation Comments					
Description:Erosion commences approximately halfway down the slope and results in sloughing into the waterside toe. Existing rip rap has been pulled off the slope at this site.					
Site ID No:412					
Site Designation:LMA-239					
Repair Type: Erosion					
Rating:Serious					
Field Date:7/17/2017					
Notes: Small erosion. Appears that site grows slowly with each high water. The center of the eosion is a deep cut that extends below rhe waterline. Possible beaver den collapse.

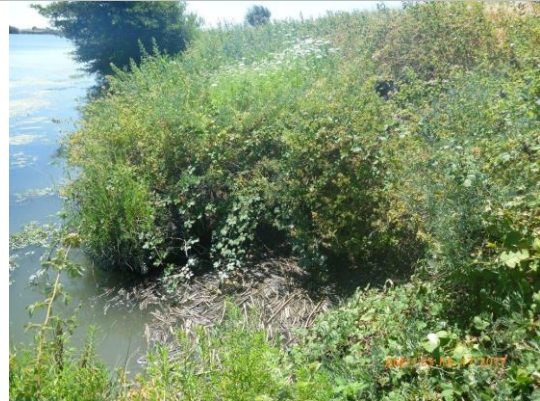
Photo 3 of 3 : SP_2019_RD2060_243_42_20190311_00075.jpg

LM Start	4.06	Rating **	A/W	Issue No.	42 (cont)	
LM End	4.08	Issue Type +	Ma	Location *		
Category	Supplemental			GPS Latitude/Longitude		
				Start	End	
Item	2017 Storm Damage			38.260789 °	38.260644 °	
				-121.696964 °	-121.696828 °	
DWR ID	DWR_RD2060_03_f_2017_42					
Comment Code						
Inspector Comment						
Levee Evaluation Comments						
Description:Erosion commences approximately halfway down the slope and results in sloughing into the waterside toe. Existing rip rap has been pulled off the slope at this site.						
Site ID No:412						
Site Designation:LMA-239						
Repair Type: Erosion						
Rating:Serious						
Field Date:7/17/2017						
Notes: Small erosion. Appears that site grows slowly with each high water. The center of the eosion is a deep cut that extends below rhe waterline. Possible beaver den collapse.

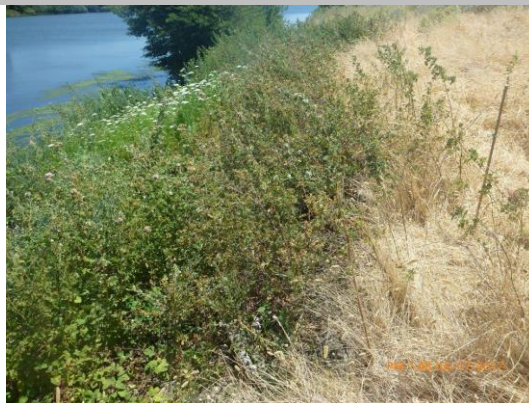
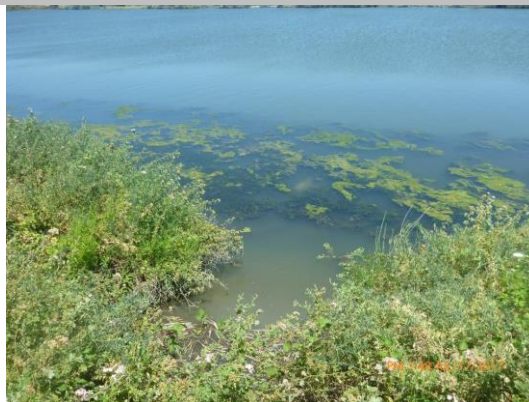
LM Start	4.06	Rating **	A/W	Issue No.	43 (cont)
LM End	4.08	Issue Type +	Ma	Location *	
Category	Supplemental			GPS Latitude/Longitude	
				Start	End
Item	2017 Storm Damage			38.260789 °	38.260644 °
				-121.696964 °	-121.696828 °
DWR ID	DWR_RD2060_03_f_2017_43				
Comment Code					
Inspector Comment					
Levee Evaluation Comments					
Description:Erosion commences approximately halfway down the slope and results in sloughing into the waterside toe.					
Site ID No:409					
Site Designation:LMA-236					
Repair Type: Erosion					
Rating:Area of Concern					
Field Date:7/18/2017					
Notes: 3' cut to slope down to water, with a 50' deep cut. Heavy veg suggests slow progression of erosion.
